Limited Visual Dam Safety Inspection Summary Report

MA-075

Reservoir 30

Limited Visual Dam Safety Inspection Conducted on: 05 April 2006

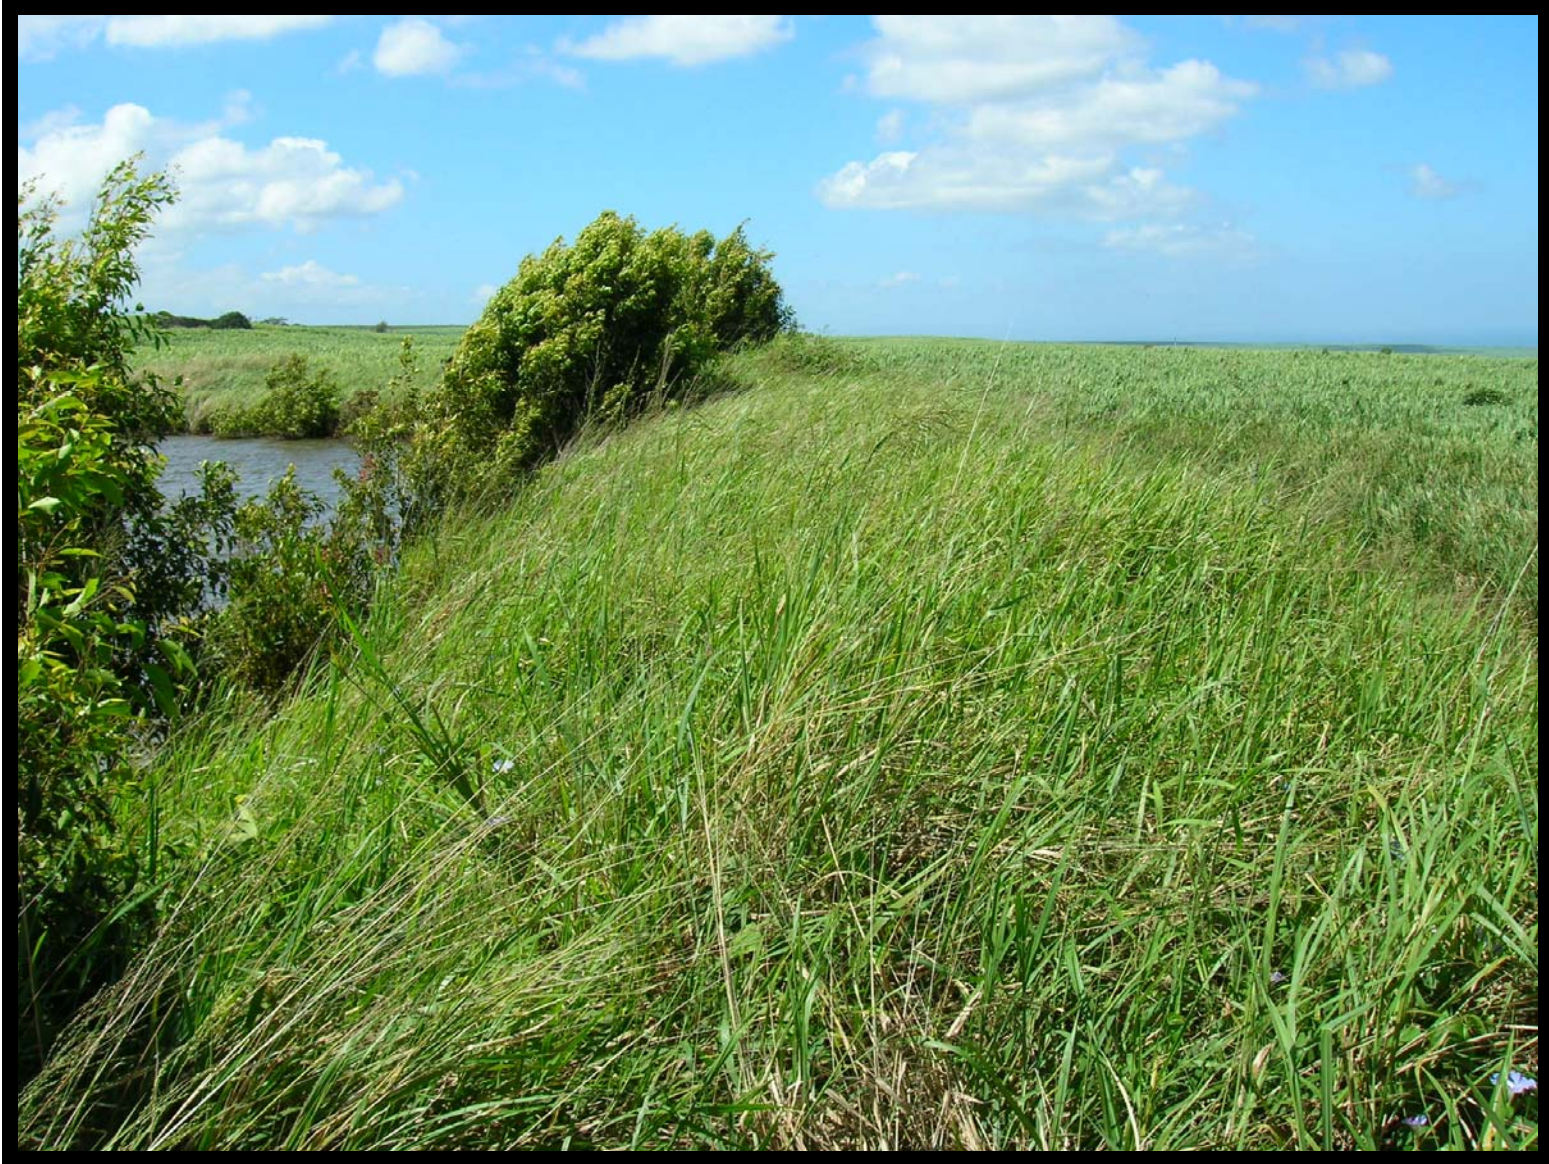
075 crest

Heavy vegetation was observed on the edges of the crest. These were primarily small woody vegetation and high grass.

- a. The dam crest appeared to be in fair to poor condition and requires corrective action.
- b. Portions of the crest were not visible due to high grass and bush vegetation. Clear high vegetation and maintain low to enable easy visual inspection.
- c. Tree(s) were observed along the dam crest. Trees have been identified as the probably cause of piping failures, and can possibly cause sever damage to the embankment if they are uprooted during a high winds. Corrective action is required to remove the tree hazards from the dam. Acceptable remedies include removal of the tree and its root structure down to a 2" diameter and reconstructing the damaged embankment section. All repair work shall be accomplished as per the requirements of licensed geotechnical or structural engineer. Routinely monitor the damaged area for signs of settlement and seepage.

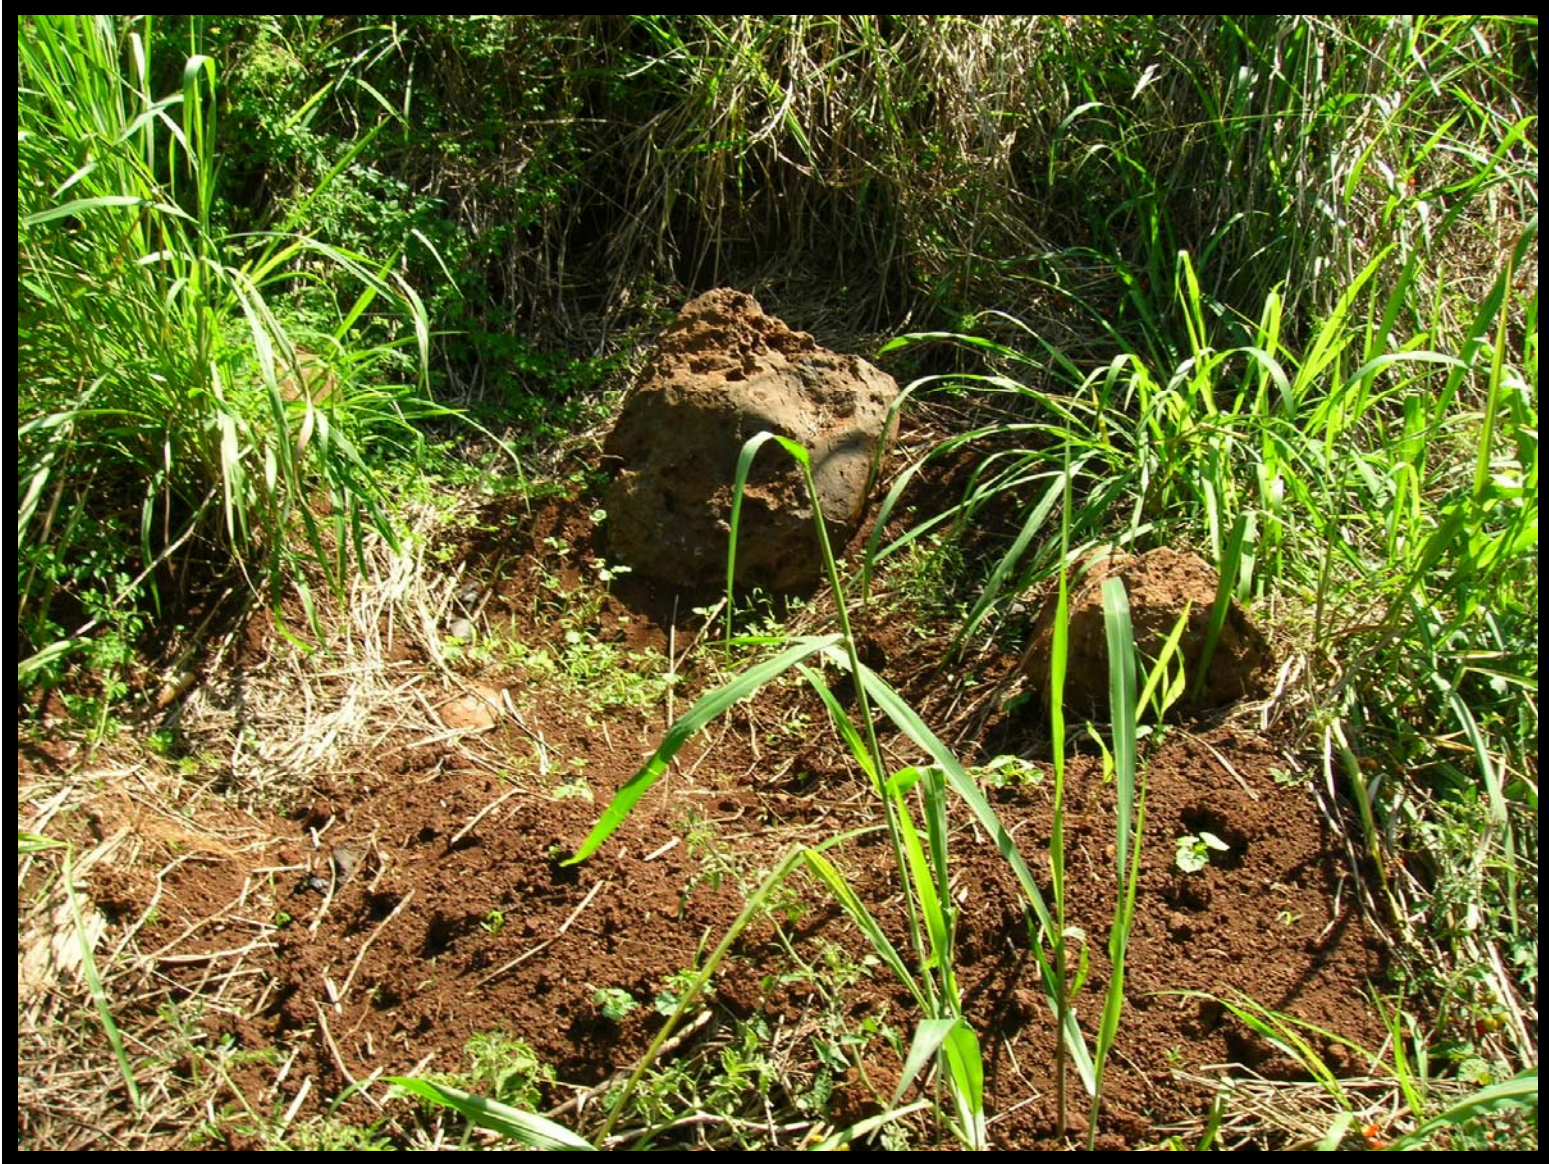
075 downstream scarp

Erosion was visible on the downstream slope, two small scarps were noted.

- e. The slope was very steep, around a 1 to 1 slope; further study is required to verify slope stability.
- f. Vertical scarps and rodent holes should be repaired/filled.

Repair downstream scarps.

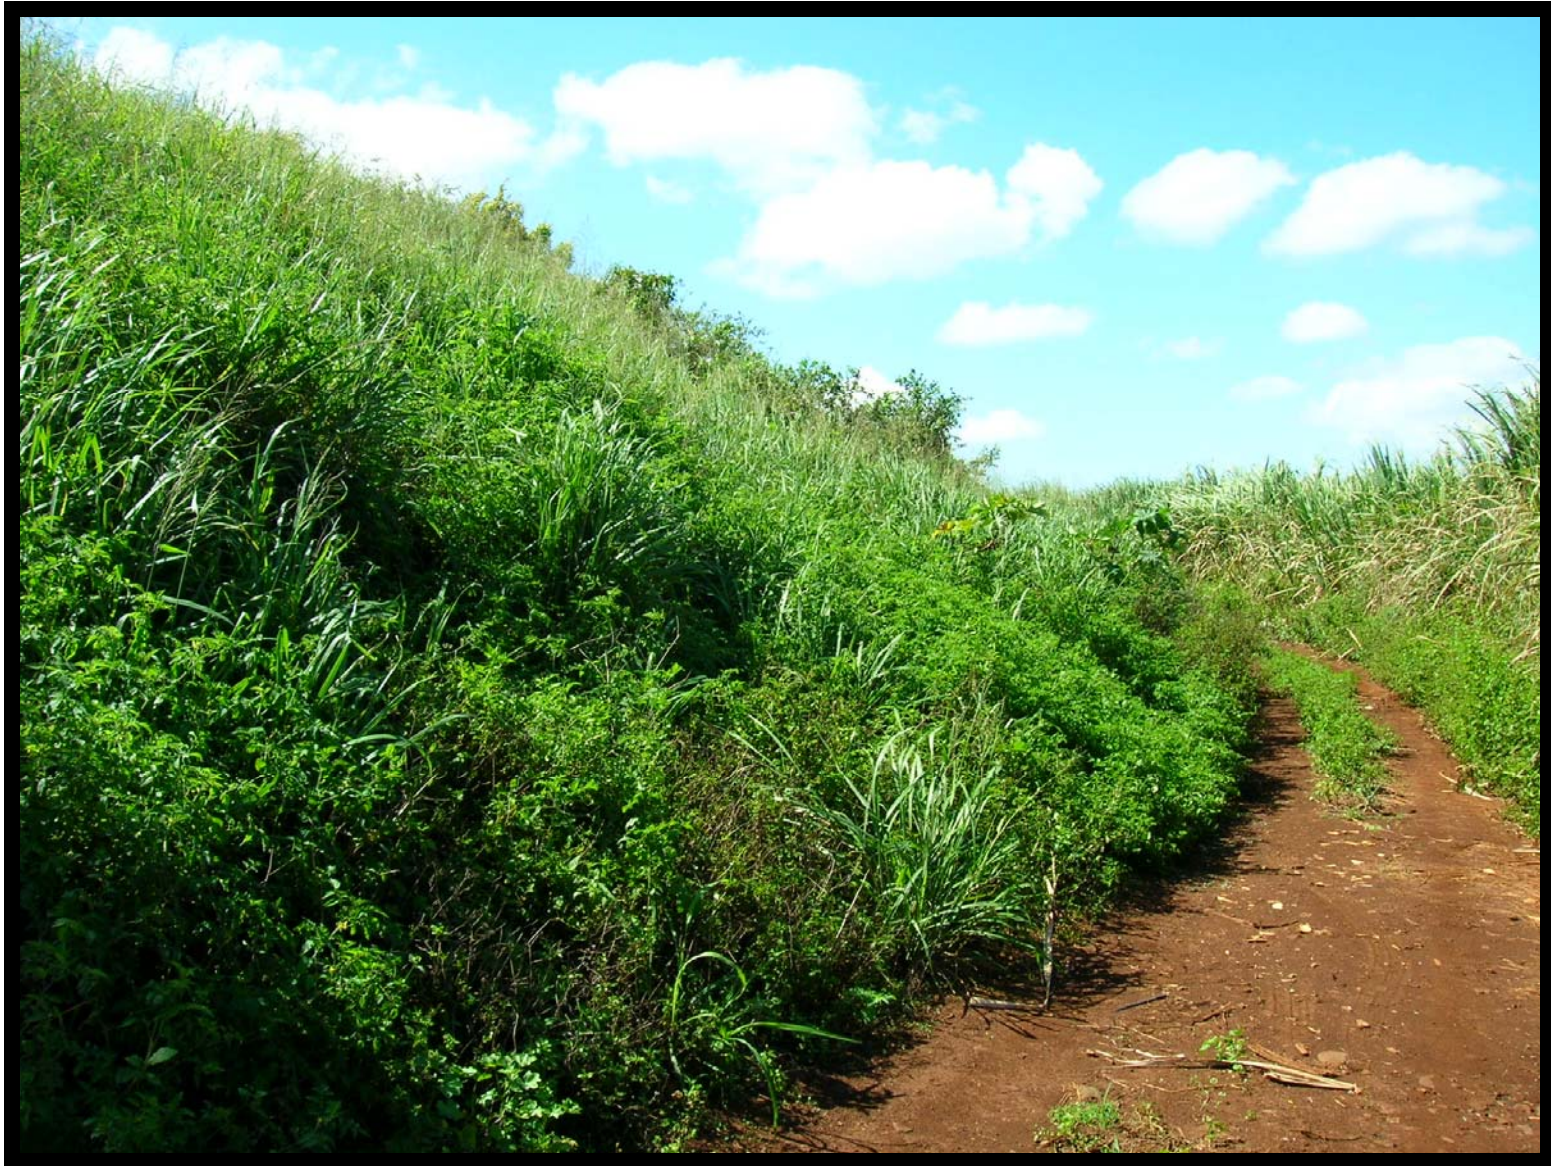
075 downstream slope

The downstream slope was in fair to poor condition and not visible due to heavy vegetation. The slope was very steep, around a 1 to .75 slope.

Vegetation was observed on the downstream slope. The majority of the vegetation was woody trees ranging from 2" to 2 feet in diameter.

- a. The downstream slope appeared to be in fair to poor condition and requires corrective action.
- b. Gully erosion was observed on the slope, which requires maintenance and repair. Repair scarps.
- c. The down stream slope was not visible due to high grass and bush vegetation. Clear high vegetation and maintain low to enable easy visual inspection.
- d. Tree(s) were observed on the downstream slope. Trees have been identified as the probably cause of piping failures, and can possibly cause sever damage to the embankment if they are uprooted during a high winds. Corrective action is required to remove the tree hazards from the dam. Acceptable remedies include

removal of the tree and its root structure down to a 2" diameter and reconstructing the damaged embankment section. All repair work shall be accomplished as per the requirements of licensed geotechnical or structural engineer. Routinely monitor the damaged area for signs of settlement and seepage.

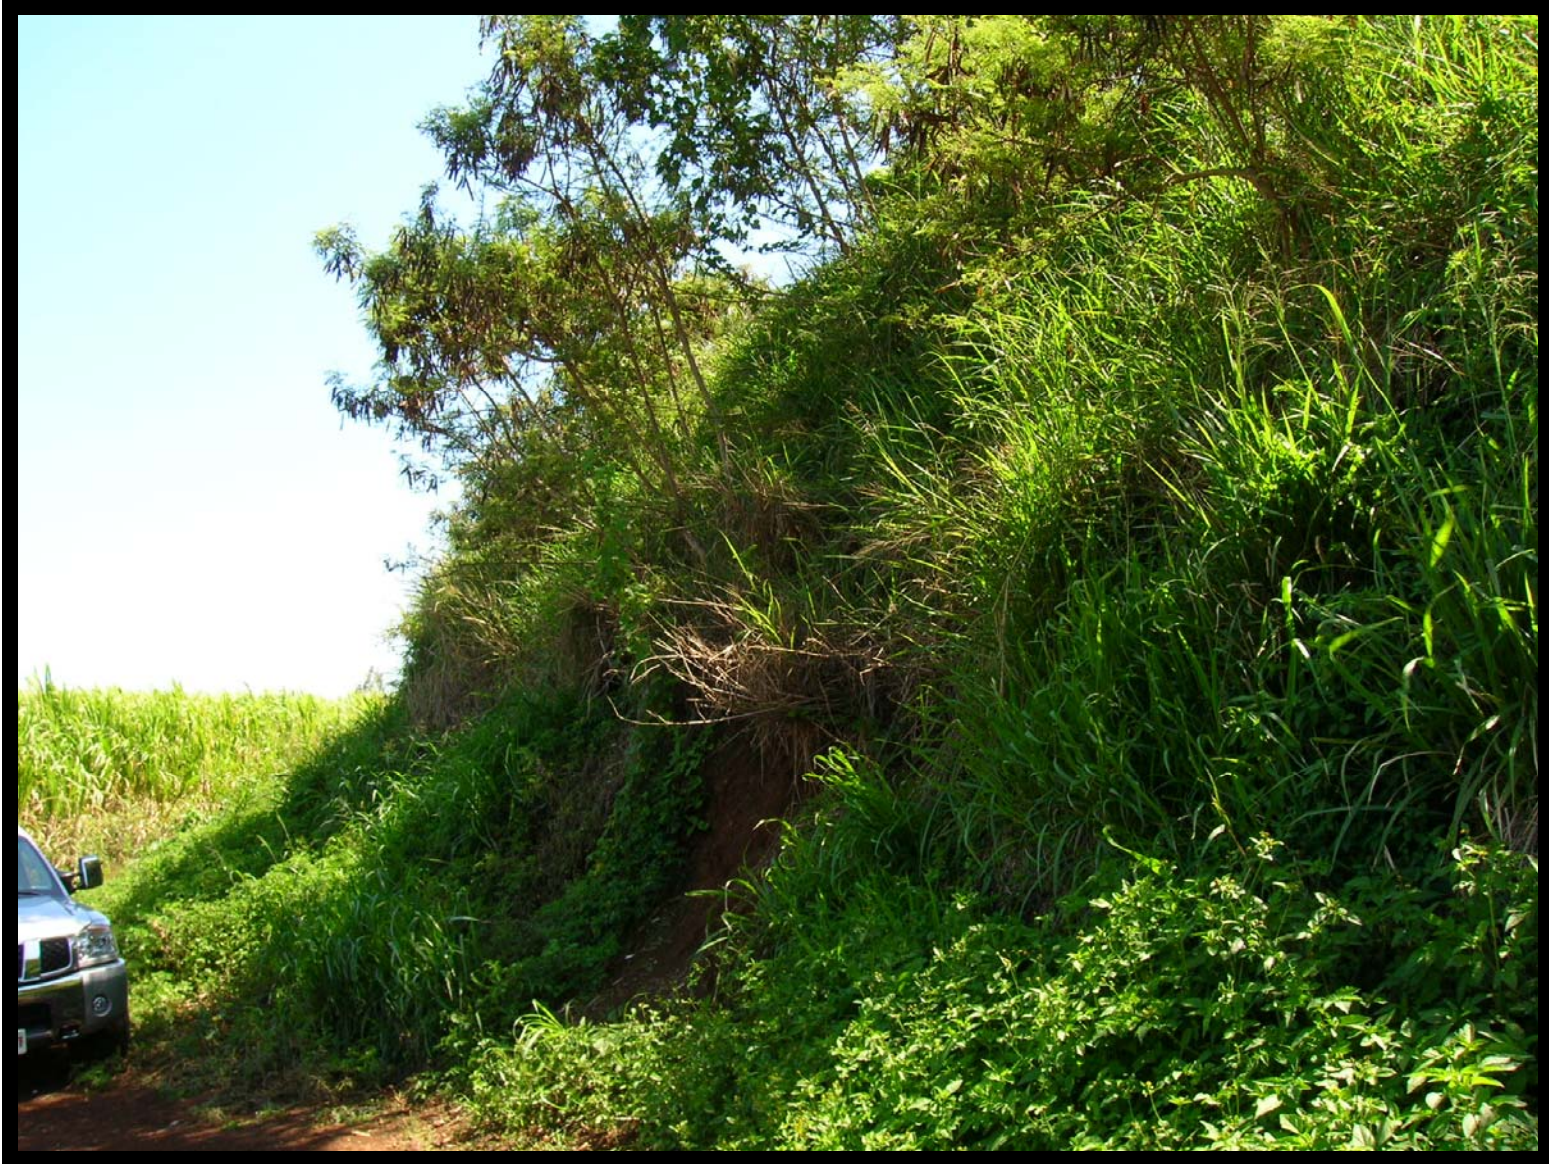
075 downstream slope 2 – slope concerns

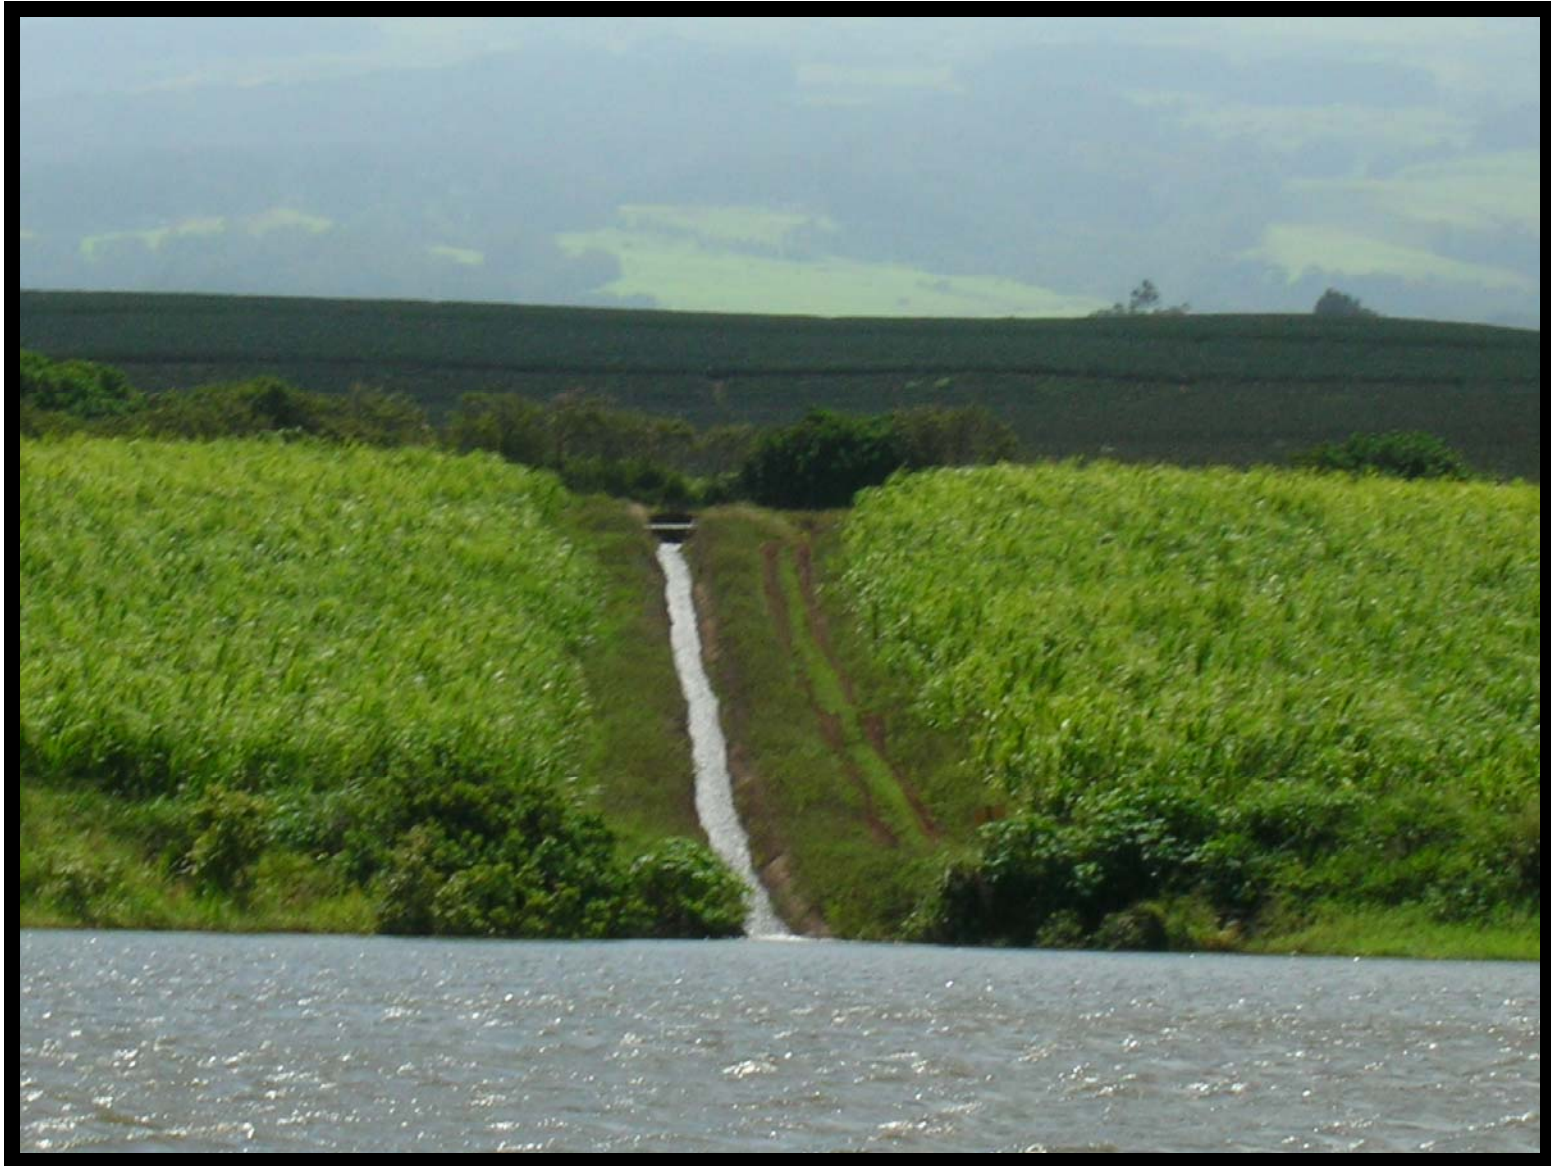
075 inlet

- a. The intake works were not tested.
- b. The intake works appeared to be in satisfactory condition, no corrective actions are required at this time.

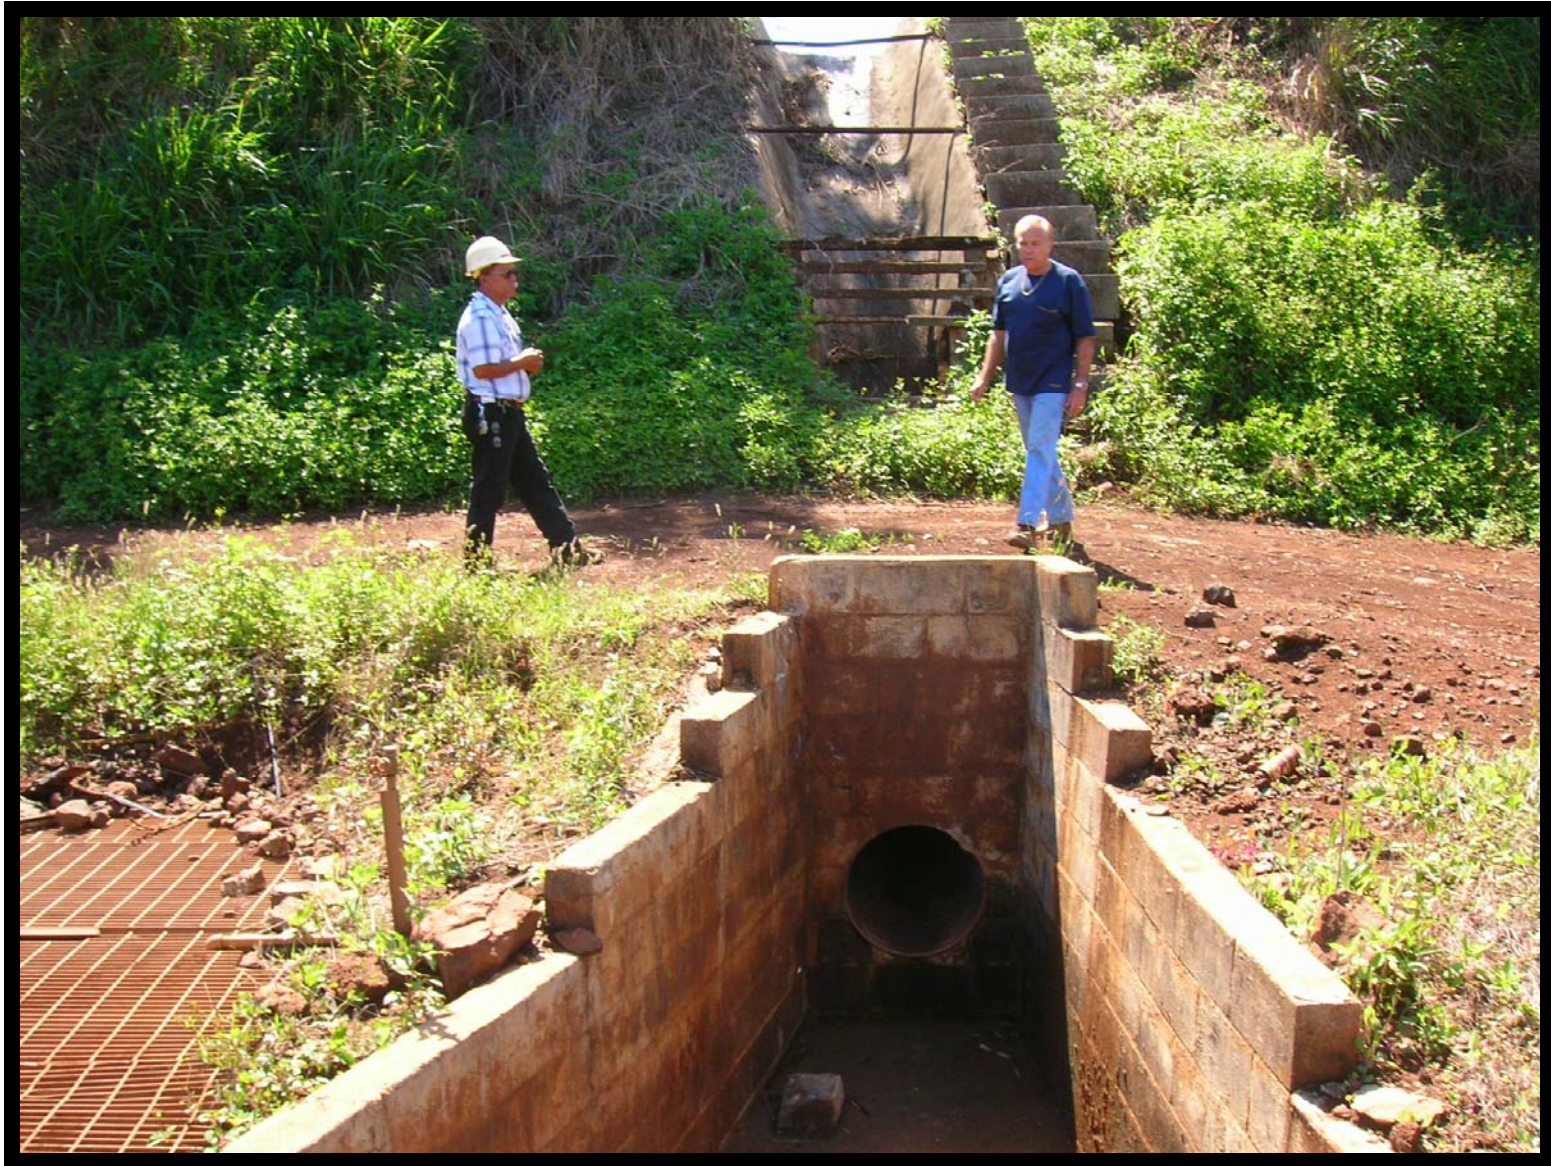
075 outlet

- a. The outlet works were not tested.
- b. The outlet works appeared to be in satisfactory condition, no corrective actions are required at this time.

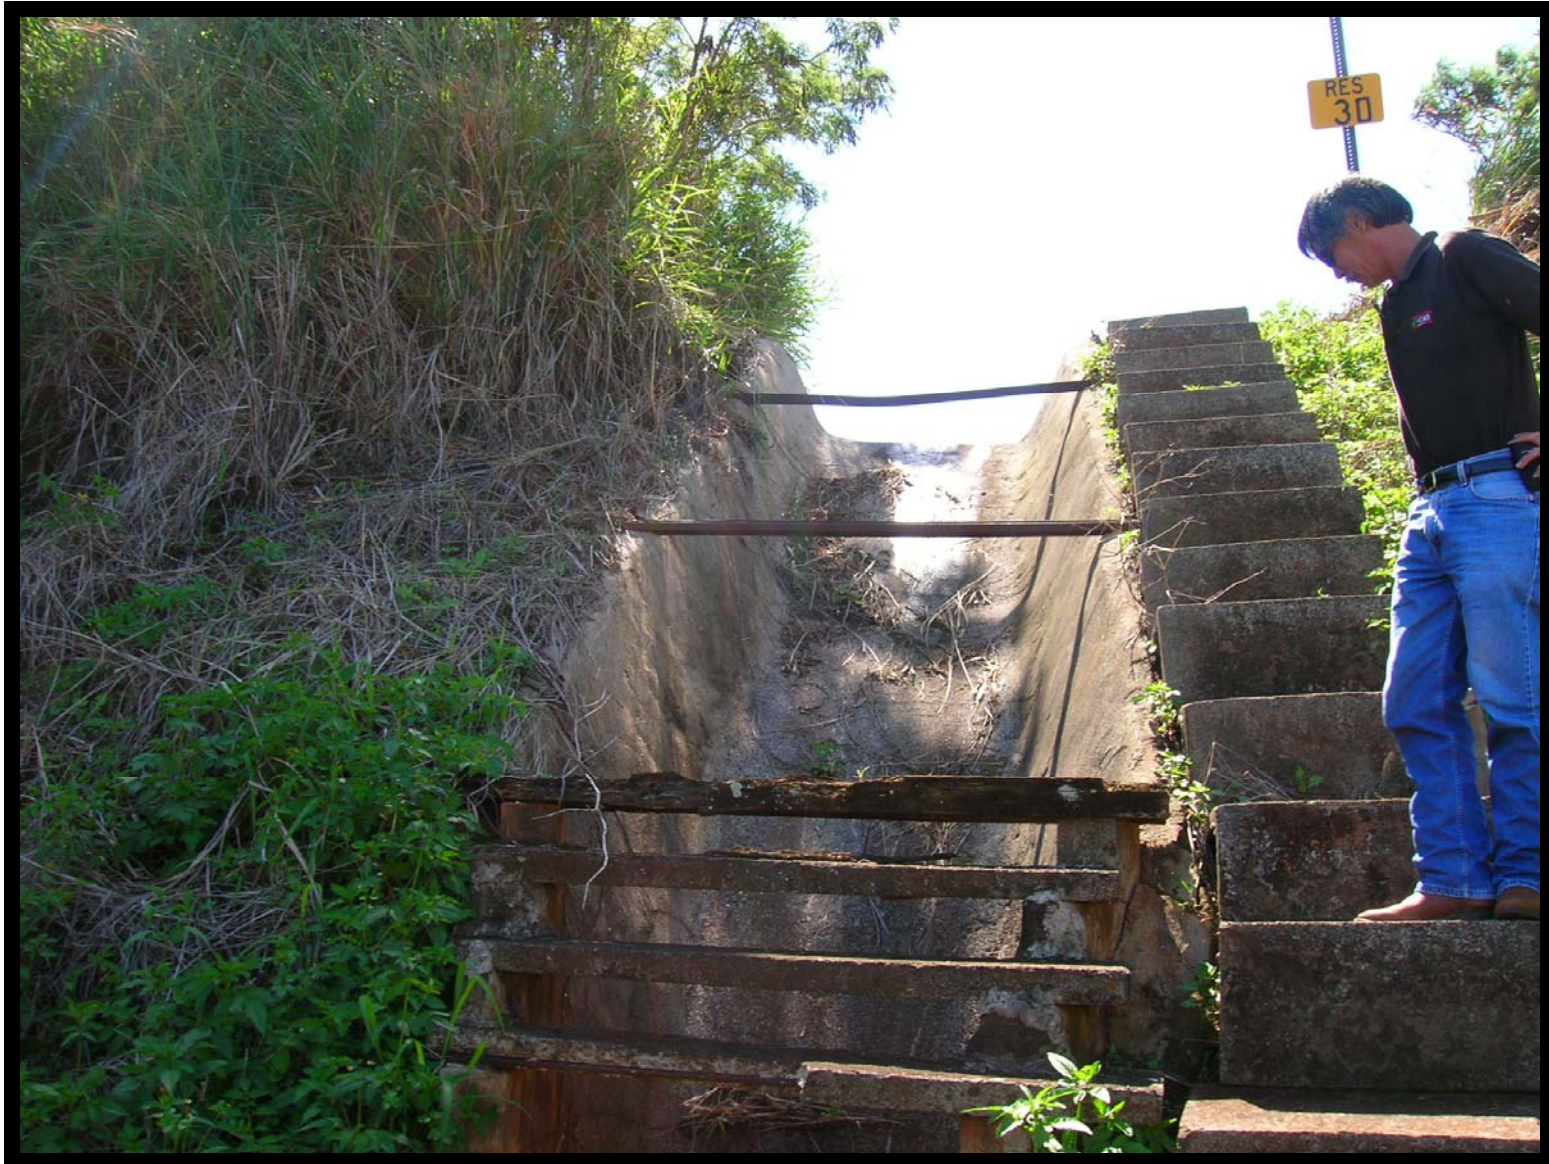
075 spillway

- a. The Spillway appeared to be in fair to poor condition and requires corrective action.
- b. Unclear if spillway is adequately sized. Spillway should pass the probable maximum flood. Verify spillway capacity and take corrective action as required.

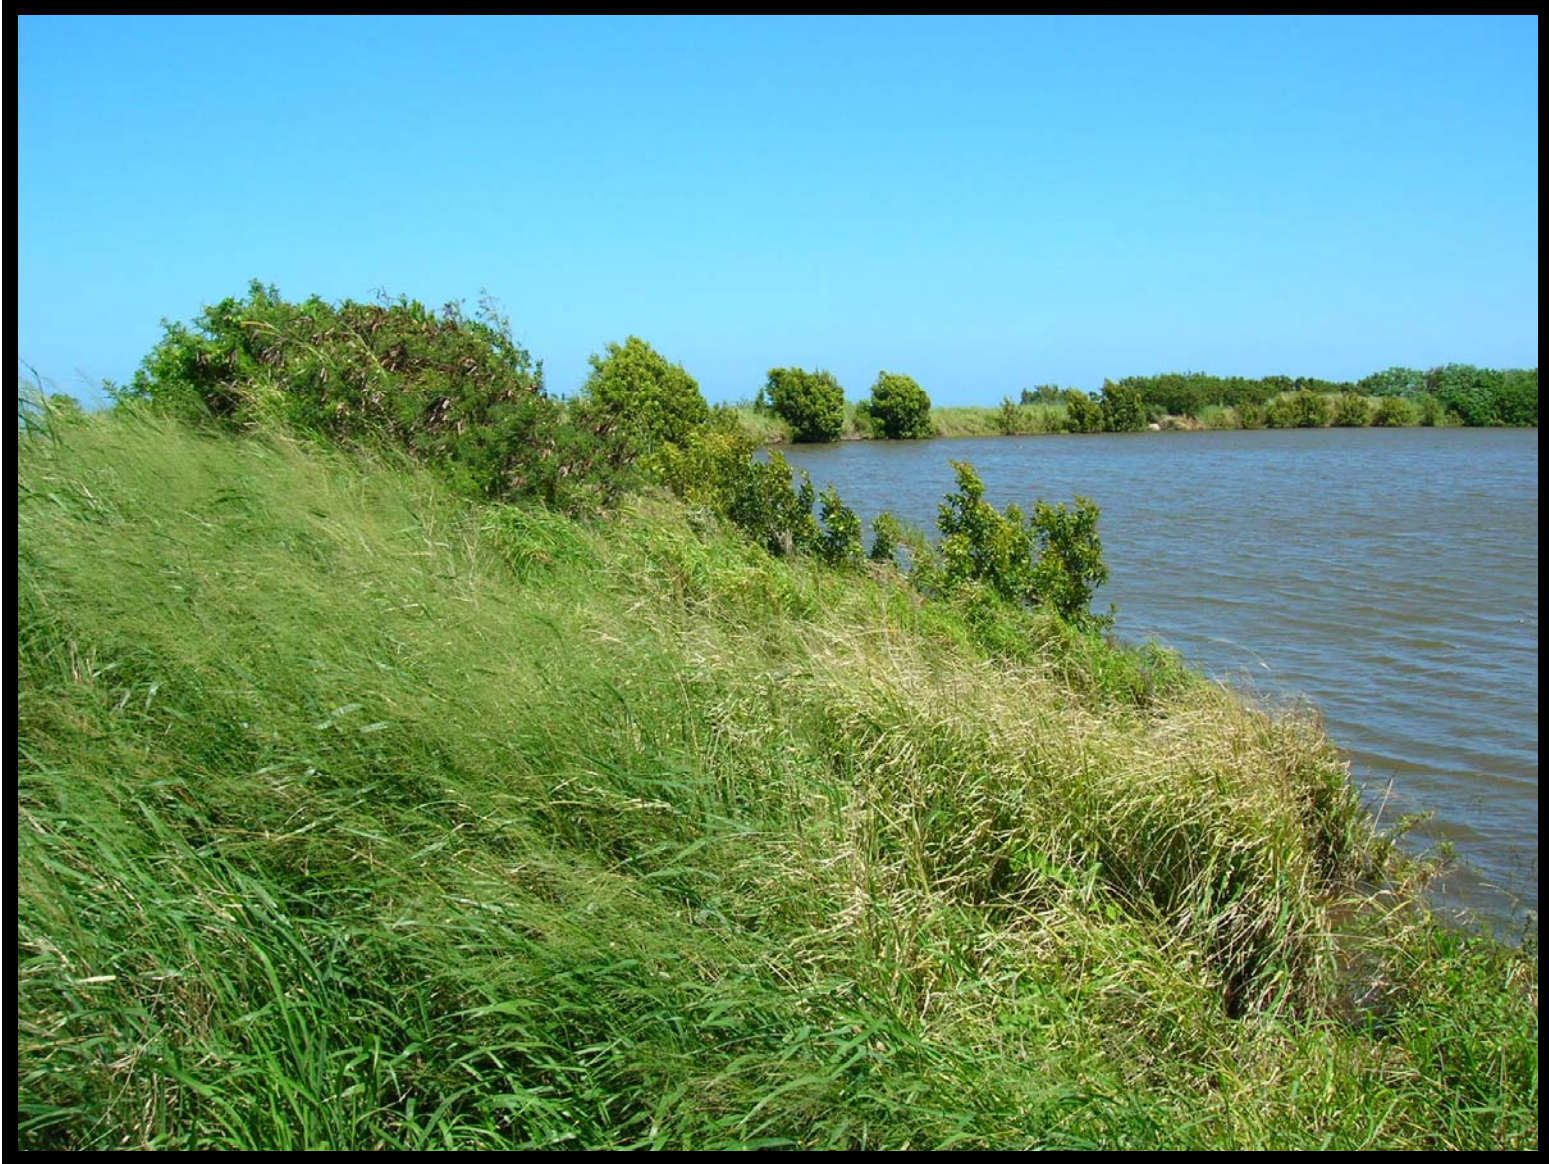
075 upstream slope

A fitted rip rap rock slope protection was observed. Vegetation was observed growing between the rocks.

- a. The upstream slope appeared to be in fair to poor condition and requires corrective action.
- b. The upstream slope was not visible due to high grass and bush vegetation. Clear high vegetation and maintain low to enable easy visual inspection.
- c. Tree(s) were observed on the dam embankment. Trees have been identified as the probably cause of piping failures, and can possibly cause sever damage to the embankment if they are uprooted during a high winds. Corrective action is required to remove the tree hazards from the dam. Acceptable remedies include removal of the tree and its root structure down to a 2" diameter and reconstructing the damaged embankment section. All repair work shall be accomplished as per the requirements of licensed geotechnical or structural engineer. Routinely monitor the damaged area for signs of settlement and seepage.
